# South Northamptonshire Council

## Conservation Advice Note No.9

### Thatch and Thatching

#### Sustaining a tradition

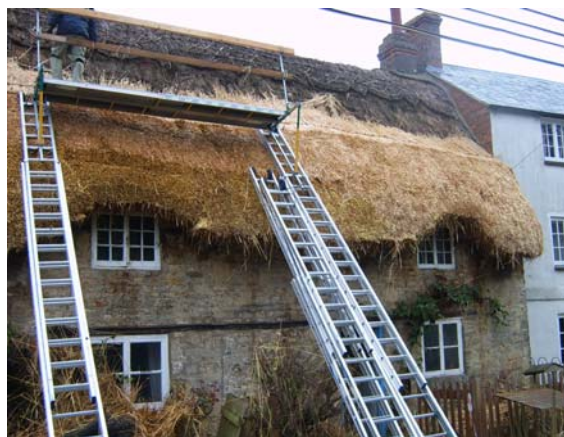
Spar-coating onto an existing thatch coat starting from eaves and moving up to ridge.

A worn long straw roof can be repaired by stripping off the top coat and overcoating with a new layer. This over coating process is known as spar coating and the covering is built up from the eaves in courses; each course overlapping the one beneath so that water is guided down the straws and off the roof at the eaves.

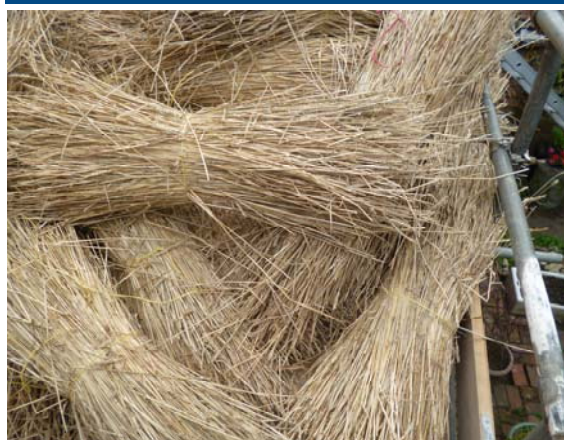
Yealms of long straw, clearly showing the intermixture of butts and ends

To prepare the material for use, the thatcher makes a bed of straw which is wetted to make it more pliable. The straw is then gathered together in bundles called 'yealms' which measure about 18 inches long by 5 inches thick, with no regard to the alignment of the stems. It is during this process that weeds and other waste are withdrawn.

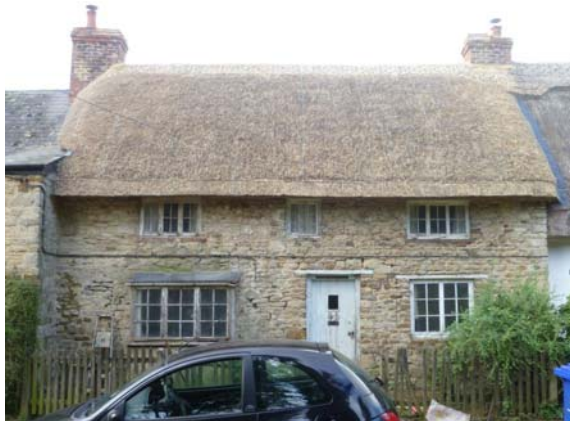
Example of a recently thatched long straw roof with a traditional flush ridge with decorative cross spars.

The eaves, verges and ridge are secured using hazel liggers and cross rods which are visible on the surface of the thatch. Because the straws lie randomly, ears and butts are both visible on the surface. This gives a distinctive shaggy look to the roof. Long straw roofs are always protected by netting and the roof is traditionally finished with a wrapover ridge flush with the main coat of the roof. It is not cut or patterned but sometimes decorated with cross spars.

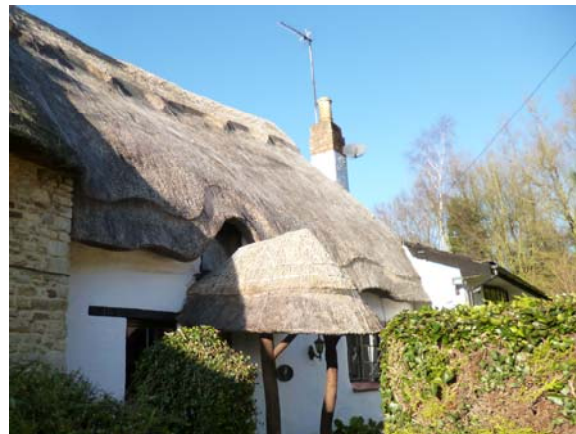
Example of a water reed thatched roof with a combed wheat block cut ridge

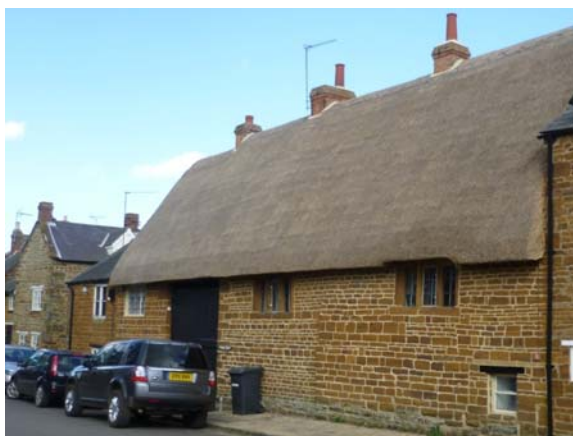
Example of a newly thatched combed wheat roof with flush ridge

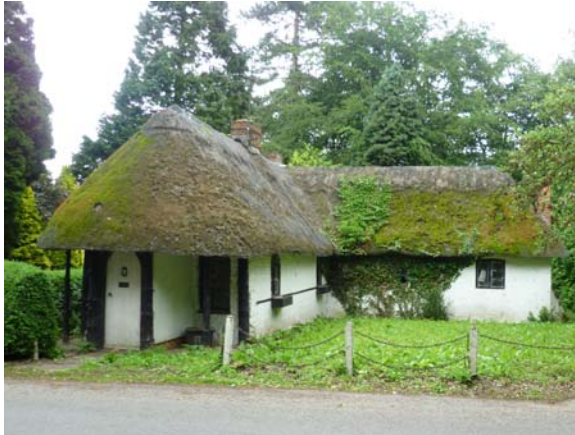
Overhanging trees, creeping plants and vegetation can all cause damage to thatched roofs.

Attention should be given to the condition of valleys and the ridge as these are likely to display the worst affects of weathering. The condition of wire netting and the presence of climbing plants and signs of birds or vermin which may be nesting in the thatch should also be considered.

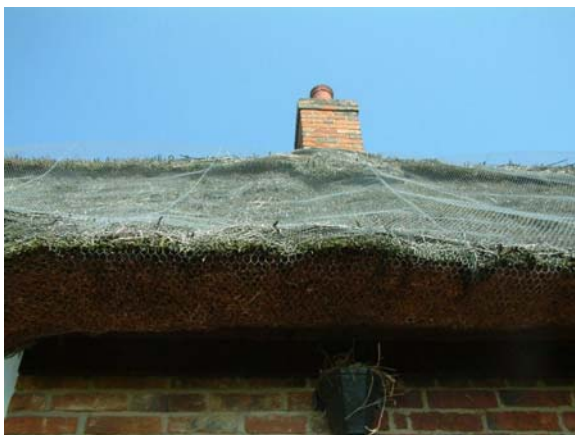
Dips in the thatch, visible spars and loose netting are all signs that a roof requires attention

The rate of weathering may however not always be consistent and there is a need to watch out for depressions, vertical lines or slippage in the thatch. Dark stains on the underside of the eaves may indicate how far moisture has penetrated into the coats. Patches of moss and fungus can also show permanently damp areas. The most crucial thing is that repair works should be carried out before rain penetrates into the base coats.

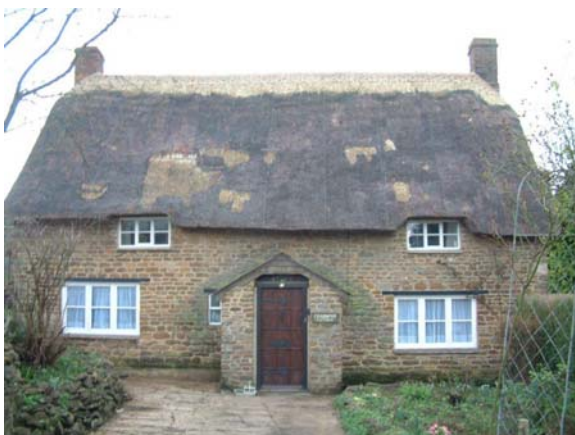
A full re-thatch is not always required with localised repairs sustaining the life of the roof.

When more substantial works are necessary owners should be careful not to accept quotes for the complete re-thatch of a roof when repairs may be more appropriate. Repairs should be carried out to match the existing top coat in both method and materials. The keeping of a logbook that shows the dates and details of thatching works is always advisable and is a good record for present and future owners.

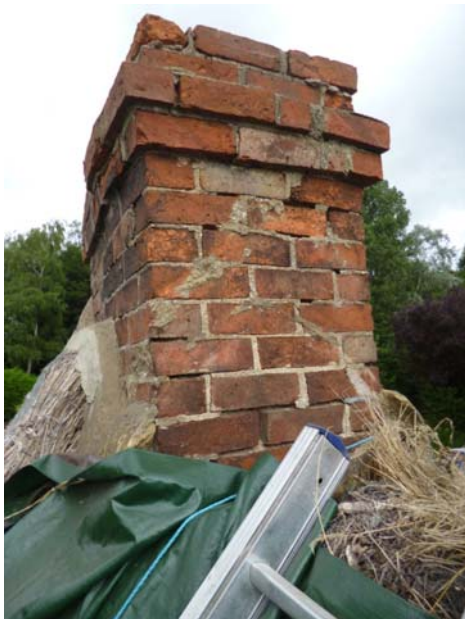
Chimneys should be routinely checked and repaired including where they pass through the thatch cover.

Chimneys may appear in good condition above the thatch however this may not be the case below the thatch line. Defective pointing or cracks in the chimney stack within the roof can allow hot gases to escape from the flue creating hot zones which may combust and cause a thatch fire. The condition of chimney stacks, especially where they pass through the thatch, are crucial and should be kept in good repair.

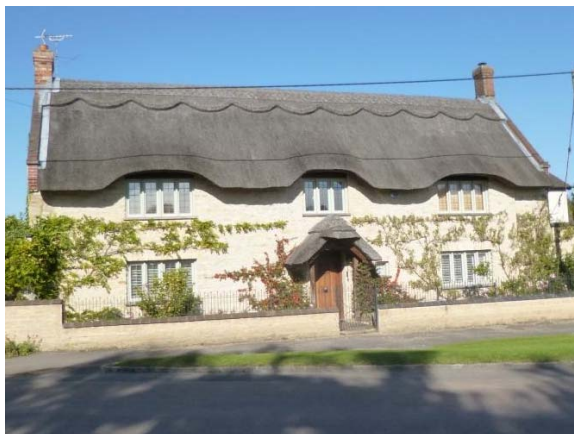
Eyebrow dormers are a characteristic of the district.

These can have several different styles of roof with that most common to thatched properties within South Northamptonshire being referred to as the eyebrow dormers. This is where the top and the sides of the dormer are thatched in one smooth sweep that rises above the eaves and joins the main pitch of the roof without any valleys creating an eyebrow-shaped at the front.

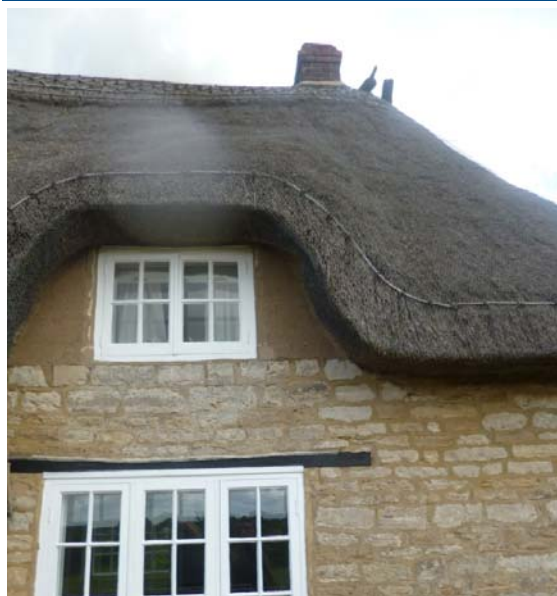
### Ridges

Exposed and susceptible to the elements ridges generally require attention earlier than the underlying roof at approximately every 8-12 years.

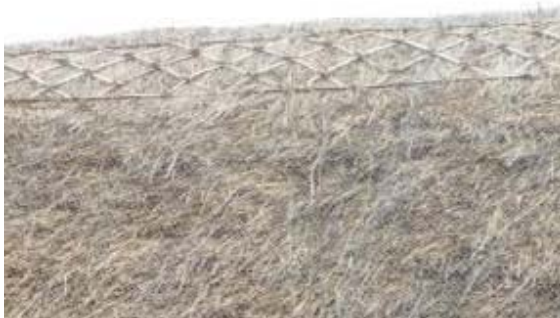
Traditional South Northamptonshire ridges are flush to the remainder of the roof with decorative cross spars. They are much cleaner and simpler in appearance than the non traditional block cut pattern ridge (see below).

The ridge is no exception to this and was traditionally constructed flush with the remainder of the roof with the criss-cross pattern created through the liggers used to hold it in place its only decoration.

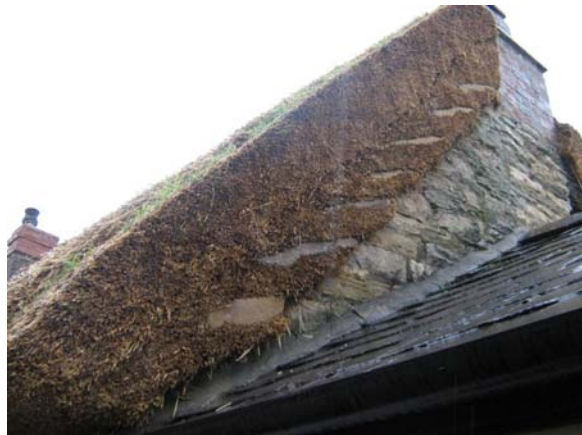
Clay was historically used to secure the thatch at the gables.

Traditionally long straw thatch would have been set at the eaves using clay or, where a roof has been re-thatched over a sound base coat, a rolled gable would have been used instead to overcome the difficulty of fixing new thatch to the gable. This

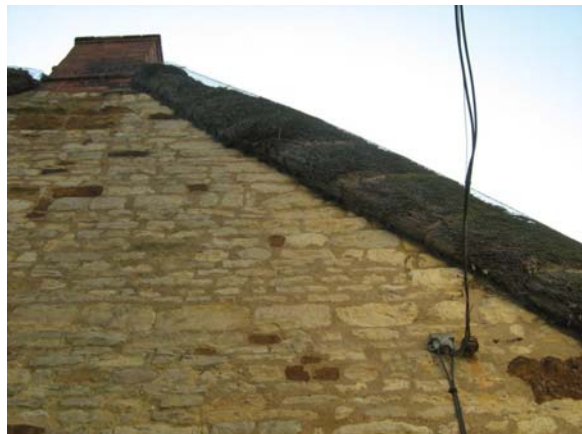
Rolled gables, not barge boards represent an attractive feature on the district's thatched roofs.

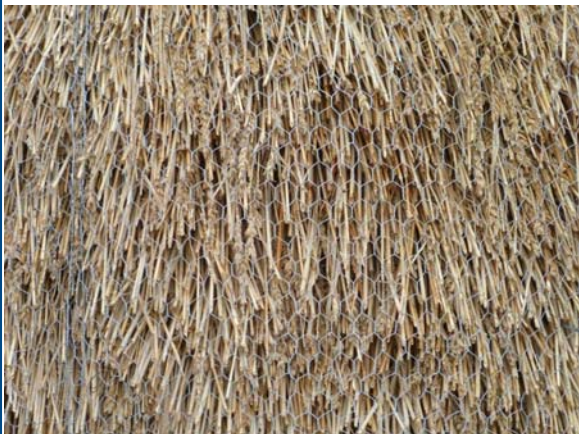
Netting is a characteristic of long straw roofs but needs to be applied carefully.

Netting is often used to protect the thatch from damage by wind and birds. This type of damage is difficult to predict and may affect one building more than another. The traditional finish of long straw is however at particular risk and it is for this reason the whole roof area is normally netted. Water reed does not usually require netting, but any straw detailing, eg at ridges, should be netted.
